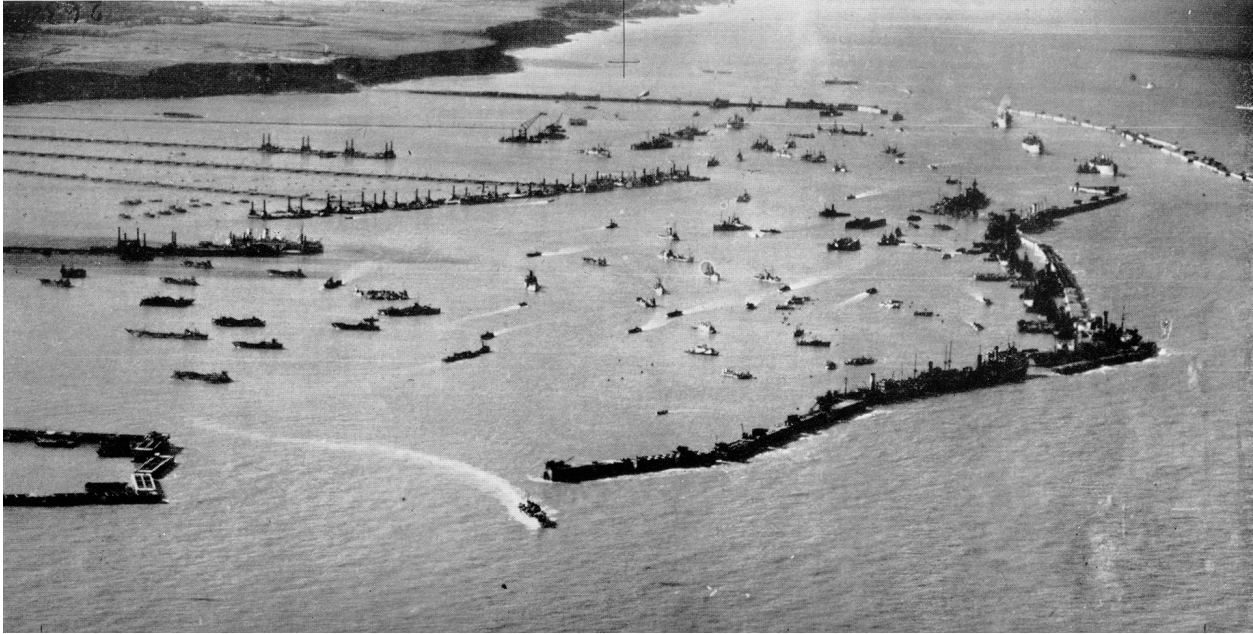
Figure I-3-14. Aerial photograph of the Mulberry “B” Harbor at Arromanches, France, June 1944 (from Institution of Civil Engineers, London, England, 1948, p. 242)
